## Tension–tension fatigue of hybrid composite rods

N.K. Kar, , Y. Hu, E. Barjasteh, S.R. Nutt

Gill Composites Center, Department of Chemical Engineering and Materials Science, Vivian Hall of Engineering 402, University of Southern California, Los Angeles, CA 90089, United States

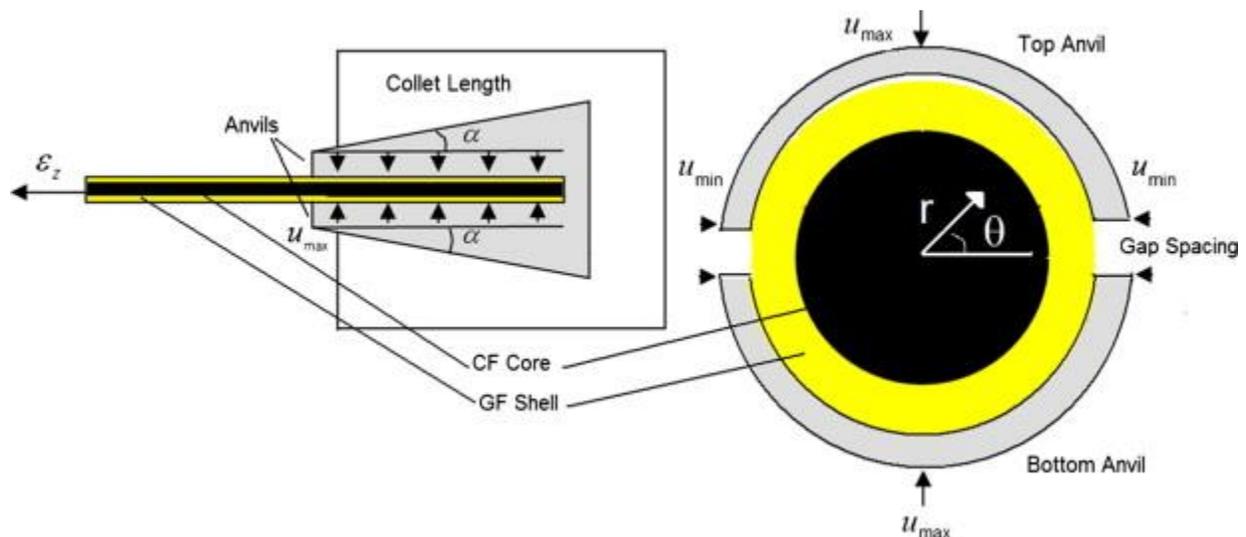
Fig. 2. 2D diagram indicating relationship between longitudinal extension on radial compression, and a cross sectional view of CF core and GF shell under mechanical grip.

A set of mechanical grips similar to those used in service (Fig. 1) were designed and fabricated for conducting tension–tension fatigue tests. As shown in Fig. 2, the grips employ a long collet that exerts a radial clamping force that increases as the tensile load is applied. The collet grip design utilizes two concave anvils to ensure that the gripping pressure applied to the surface of the rod is sufficient to prevent slip. This leads to a variation in radial displacements, with the maximum displacement occurring on the GF shell surface in regions farthest from the gap spacing, indicated in Fig. 2. The friction force between the grip and the rod increases with radial displacement, which resists slippage under higher axial loads. The maximum radial displacement ( $u_{max}$ ) is a function of the applied tensile displacement ( $\epsilon_z L$ ) and the grip angle ( $\alpha$ ):

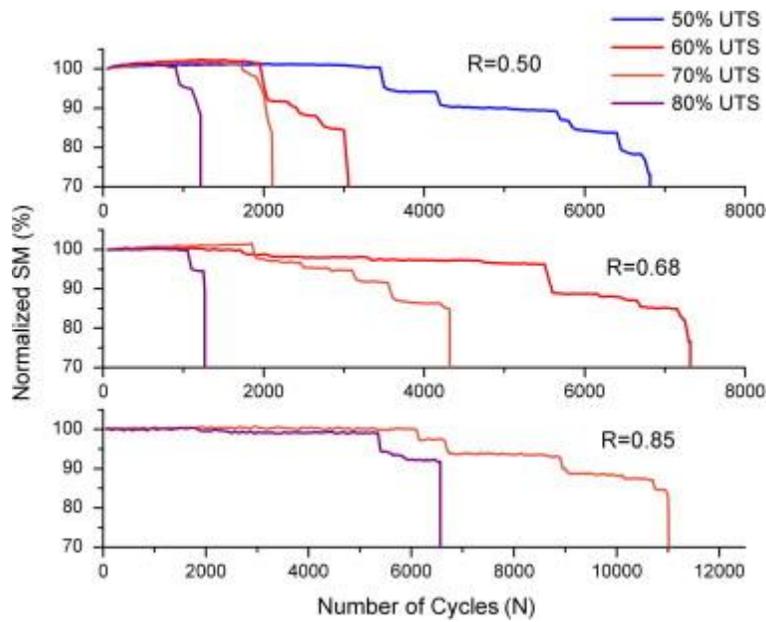
Fig. 3. SM loss at three R-ratios and four stress levels.

The tension–tension fatigue response for the three R-ratios and four MAS levels is shown in Fig. 3, where the normalized SM is plotted against the number of cycles. At all R-ratios, increasing the MAS caused the number of cycles to failure to decrease. Increasing the R-ratio caused the fatigue stress (taken as the MAS to cause catastrophic fatigue failure) to increase. At  $R = 0.50$ , catastrophic failure occurred for all four MAS levels, while at  $R = 0.68$ , failure occurred only for  $MAS \geq 60\%$  UTS, and at  $R = 0.85$ , failure occurred for  $MAS \text{ stress} \geq 70\%$  UTS. All R-ratios show the same trend in modulus loss – the SM remains constant for the initial portion of the fatigue life until damage events cause abrupt SM drops, with ensuing catastrophic failure. The first drop in SM indicated that composite damage had occurred, but was still able to carry the cyclic load. The applied cyclic load was redistributed and a slightly lower, steady SM was maintained temporarily while the load cycles continued. Subsequent modulus drops transpire, with plateaus at lower SM values. Eventually the fatigue damage saturated, and catastrophic failure occurred, manifested as a precipitous drop in SM, taken as the fatigue life ( $N_f$ ). Fig. 3 also shows that for any fixed R-ratio, a shift in material behavior occurs as the MAS level increases. In particular, for small MAS values, multiple small decrements in SM are observed, while for larger MAS values, the SM remains nearly constant over most of the fatigue life, and rapid failure and modulus loss occurs near the end of fatigue life. The tension–tension fatigue behavior of the hybrid composite rod differs from that of typical composite laminates, where investigators normally observe a sigmoidal response of stiffness deterioration earlier in life, followed by a steady loss in stiffness and eventual catastrophic failure [19].

Fig. 3 shows that the hybrid composite undergoes a transition from continuous degradation of the SM to a sudden-death failure with increasing MAS levels and strain amplitudes. In previous fatigue studies, progressive damage mechanisms were responsible for the steady degradation of the SM where a zone of damage was traced, while non-progressive damage mechanisms were indicated by a sudden-death behavior of the SM [24] and [25]. Progressive damage mechanisms in composites are matrix-dependent failure modes, and typically start within the matrix and propagate along the fiber/matrix interface. In contrast, non-progressive damage mechanisms are fiber-dominated failure modes, and are catastrophic in nature. Table 3 shows that lower R-ratios corresponded to higher

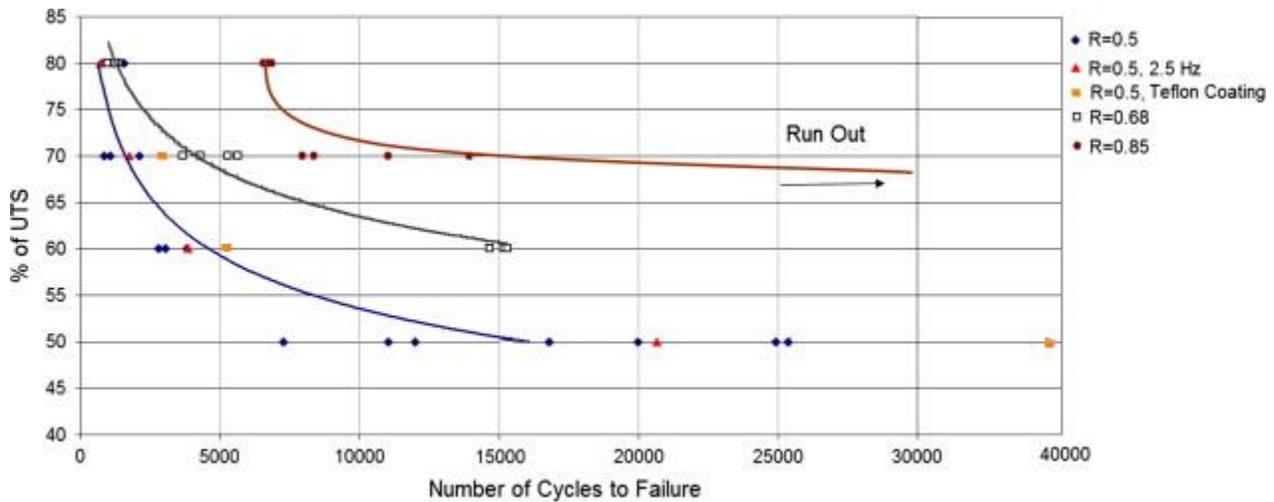
Fig. 4. S–N curve at 3 *R*-ratios showing endurance behavior.

The S–N curves in Fig. 4 show the effects of the MAS level and R-ratio on fatigue life. Increasing the MAS level (for any R-ratio) reduced fatigue life. The S–N curves show that for a fixed MAS level, lower R-ratios resulted in a shorter fatigue life. At 80% UTS, the R-ratio had little effect on fatigue life, as  $N_f$  varied slightly between 1000 and 1500 cycles for R-ratios 0.50 and 0.68, and increased to 7000 cycles for  $R = 0.85$ . However, at a MAS level of 60% UTS, the fatigue life increased from ~3000 (for  $R = 0.50$ ) to 15000 cycles (for  $R = 0.68$ ) and was beyond 1 million cycles for  $R = 0.85$ . Thus, the effect of R-ratio on fatigue life was more pronounced at lower stress levels.

where *A* and *B* are material parameters. The data conform to this relationship, as shown in Fig. 4, indicating the existence of an endurance limit, below which fatigue failure does not occur. As shown in the plots, fatigue life is affected by the *R*-ratio. This is particularly apparent when observing the log–log relationship at the two lower *R*-ratios (*R* = 0.5 and *R* = 0.68):

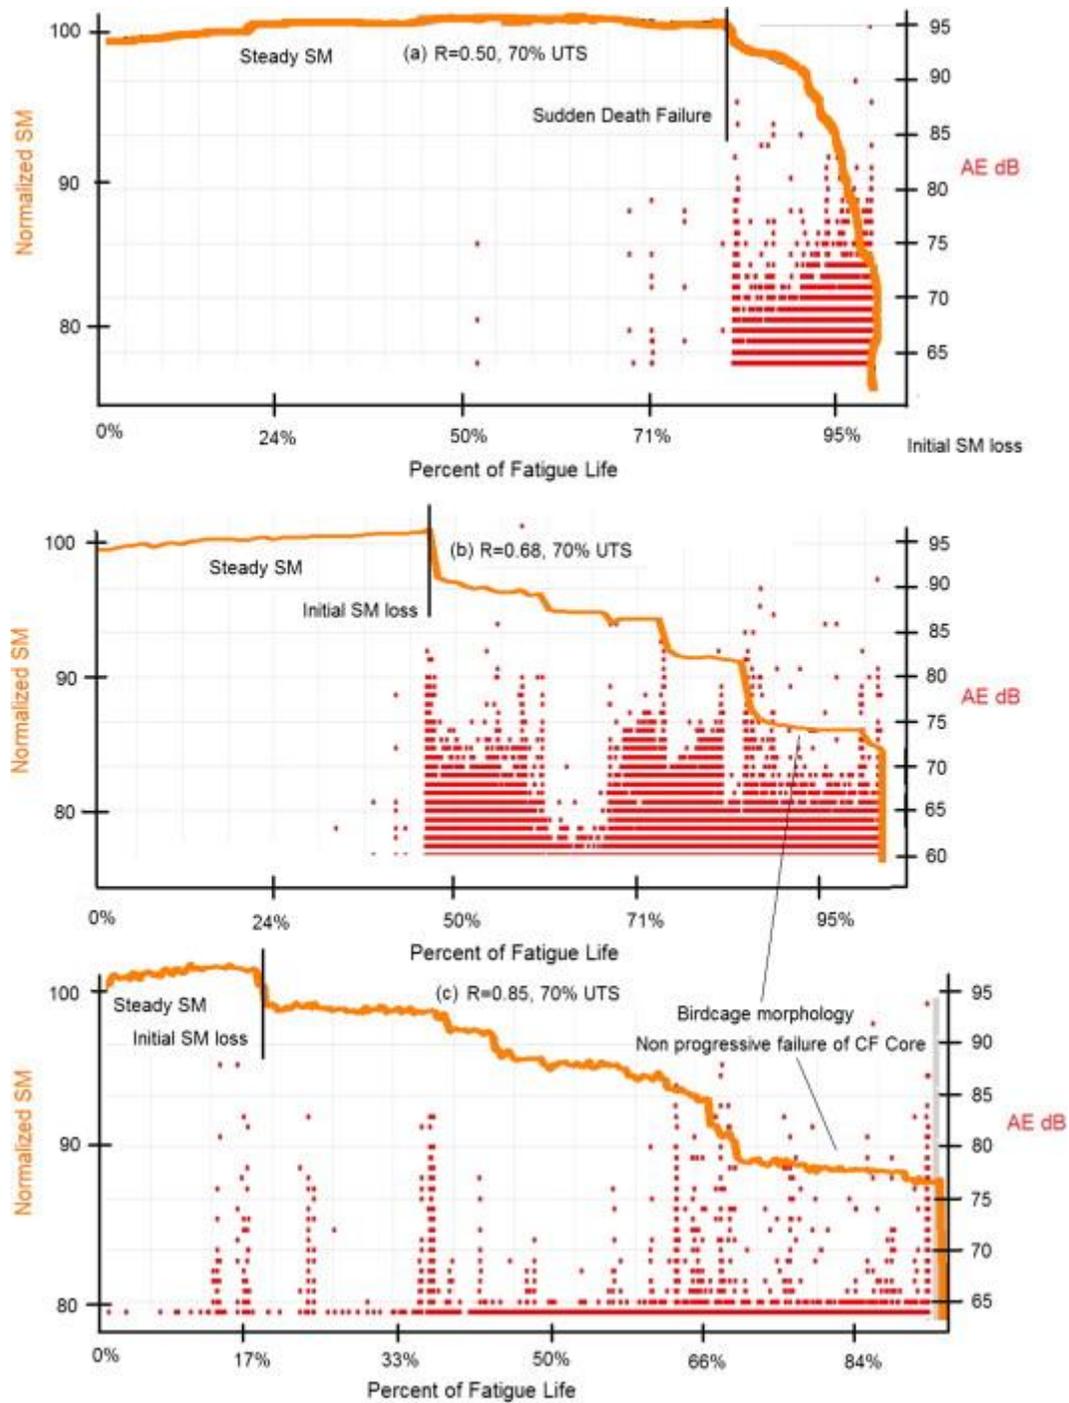
Fig. 5. AE hits and damage versus fatigue life for a maximum stress level of 70% UTS at three R-ratios.

The AE amplitude response is shown concurrently with the SM loss in Fig. 5 for a fixed MAS level of 70% UTS at the three R-ratios. Each red dot represents a single hit, corresponding to the detection of an AE signal arising from an active damage mode. The data in Fig. 5 show that during the early stage of tension–tension fatigue, the SM was nearly constant, and no AE signals were detected, indicating negligible damage. The end of the early stage was marked by a sharp drop in the secant modulus, accompanied by a rise in the value and number of AE hits, indicating the onset of a fatigue damage mechanism. The audible damage events occurred within the GF shell and originated near the grip/gauge length transition region, shown in Fig. 6. Fretting fatigue damage at the GF surface, caused by the collet fixture, led to the formation and propagation of a radial crack through the GF shell, which was subsequently deflected at the GF/CF interface and propagated as a longitudinal crack along the gauge length (see micrograph in Fig. 6). This pattern of initial failure manifested as bundles of GF fibers separating from the GF/CF interface, as shown in Fig. 6.

The high strain amplitude of 0.78% led to sudden-death failure of the entire hybrid composite, as shown in Fig. 5a. This trend is consistent with Talreja's investigations showing that higher maximum strain amplitudes corresponded to non-progressive catastrophic failure [26]. In Fig. 5a, AE activity occurred only in the last 20% of the fatigue life, while at higher R-ratios, AE activity initiated within the first 20–50% of life, and was present throughout, as shown in Fig. 5b and c. This continuous AE activity throughout most of the fatigue life reflects a progressive damage mechanism. The scaled AE activity early in fatigue life was an indication that increasing the R-ratio led to the activation of progressive damage mechanisms, at lower strain amplitudes. Lower MAS levels and higher R-ratios produced lower strain amplitudes, leading to early, progressive damage of the GF shell and higher fatigue lives. On the other hand, higher MAS levels and lower R-ratios produced higher strain amplitudes, leading to non-progressive, sudden-death failure of the entire hybrid composite and shorter fatigue lives.

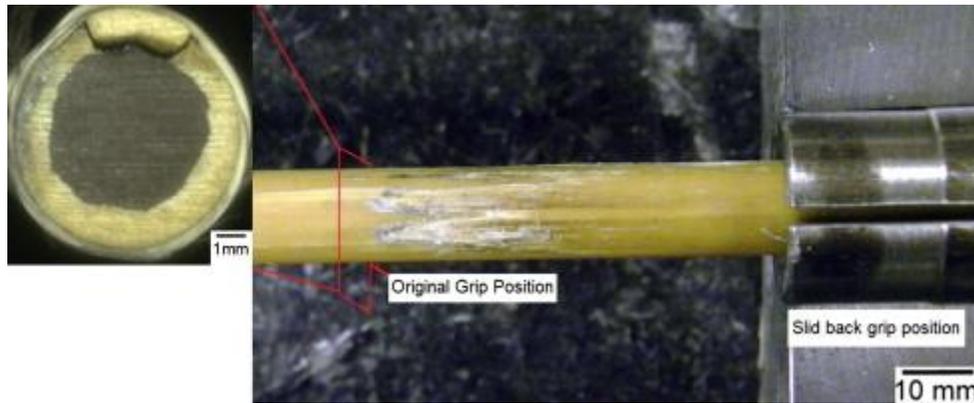
Fig. 6. Damage initiates as cracks in the GF shell near rod/grip zone along the CF/GF interface. Prominent drops and plateaus in *SM* occur after the initial *SM* loss, as shown in Fig. 5b and c. In particular, for *R* ratios of 0.68 and 0.85, progressive damage occurs within the GF shell, where each drop in *SM* corresponds to an AE amplitude peak. The damage mode was progressive because each *SM* drop was correlated with a macroscopic damage event accompanied by a burst of AE signals. The peaks in AE amplitude in Fig. 5b and c represent progressive longitudinal splitting of the GF shell, and are characterized by a high amplitude output range of 80–95 dB. Each longitudinal split in the GF shell originated within a grip and propagated along the gauge length, both as a radial crack in the GF shell and a longitudinal crack at the GF/CF interface. The fatigue resistance of unidirectional composites reportedly depends on the susceptibility to longitudinal splitting [21]. In the present investigation, the GF shell showed clear signs of this mechanism. These wedge-shaped GF bundle cracks grew parallel to the fiber direction, and were responsible for the progressive step-wise losses in the *SM*.

were also evident along the surface of the GF shell that was in contact with the collet grip (Fig. 6). Fretting fatigue damage was manifested in the AE data as signals of repeated low-AE-amplitude (60–70 dB, Fig. 5). These signals increased in frequency with fatigue life, demonstrating that fretting fatigue of the GF shell was an important damage mechanism contributing to fatigue failure. Kim and Ebert [22] determined that the surface integrity of the glass fiber was the most critical factor limiting the fatigue life of a GF composite, and surface integrity can be compromised during fatigue loading because of fiber–fiber contact (fretting type damage) produced during high-amplitude stress cycling [23].

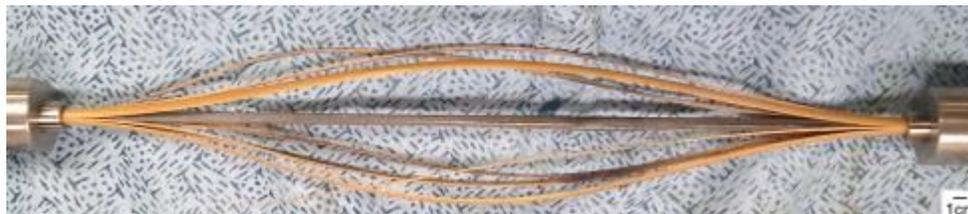
Fig. 7. Complete GF/CF separation termed bird caging.

The tension–tension fatigue behavior of the hybrid composite led to complete failure of the CF core because of a transition in damage mechanisms and load sharing behavior. The growth of multiple longitudinal cracks (along the CF/GF interface) led to a 10–20% loss in *SM* after ~70% of the fatigue life, (see arrow in Fig. 5b and c). Eventually, these cracks led to complete separation of the GF shell from the carbon fiber core, corresponding to the lowest *SM* plateau prior to catastrophic failure. This resulted in a bird cage morphology, as shown in Fig. 7. At this stage, (complete shell/core separation), the CF core supported all of the applied cyclic loads. Fig. 5b and c show that after the bird-caging effect, the *SM* remained constant until final failure, and there were no prominent peaks in AE signals until the CF core failed catastrophically.

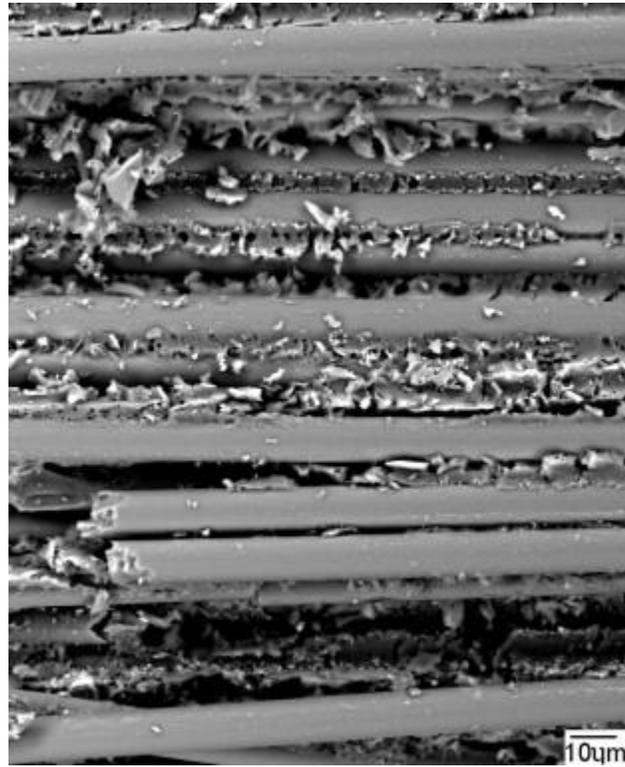
*Fig. 8. Catastrophic failure of CFs at end of fatigue life.*

The failure-causing damage to the CF core was characterized by multiple fiber breaks and fiber/matrix interface separation, as shown in Fig. 8. While some of the outermost fibers of the CF core detached with portions of the GF shell during bird-caging, the bulk of the CFs did not separate, and the majority of the core remained intact until catastrophic failure occurred. There was no evidence of progressive fatigue damage in the CF core, and the fracture surfaces were similar to the failures observed in tensile strength tests. Supporting this contention, the normalized SM remained nearly constant during the final 20–30% of fatigue life (at 80–90% of SM), a period during which the load was supported solely by the CF core (see Fig. 5b and c). During this period, the number of random fiber breaks increased with the number of cycles, but because the SM remained constant, the damage was negligible and the failure of the CF core was non-progressive. Eventually, the distribution of broken carbon fibers reached a critical stage at which point catastrophic failure occurred, corresponding to a final peak in AE amplitude (near 95 dB) and a drop in SM to zero.

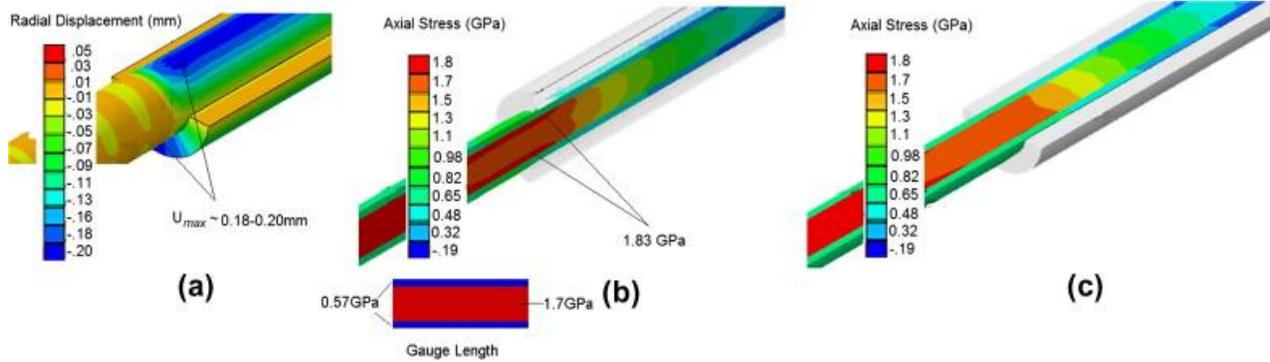
Fig. 9. (a) Non-uniform radial displacement of grip, (b) stress distribution in plane with maximum radial displacement and (c) stress distribution in plane with minimum radial displacement.

Stress concentrations within the grip were a function of the distribution of radial displacements, which were determined by finite element (FE) analysis. Fig. 9a shows the distribution of radial displacements at 50% UTS (axial load) under an imposed radial displacement in a 3D FE model. The radial displacements were slightly non-uniform as a result of the slit spacing inherent in the collet grip design (see Fig. 2). The analysis revealed that the greatest radial displacements occurred near the top and bottom of the grip ( $u_{max}$  in Fig. 2), where the greatest radial loads occurred. These regions experienced minimal fretting damage because the high radial displacements prevented axial displacements (slippage). Large radial displacements can cause high transverse compressive stresses to develop that can crush composites [28]. Thus, radial displacements ideally should be sufficiently large to prevent fretting and slip, but small enough to prevent compressive overload and crushing (not observed in this study). The smallest radial displacements ( $u_{min}$  in Fig. 9a) occur near the collet slit where the two concave anvils of the collet meet. This analysis is consistent with Fig. 6, which shows the formation of fatigue cracks in regions where radial displacements are minimal and where the sharp edges of the collet exist. These sharp edges created grooves on the GF surface (see Fig. 6), and allowed the composite rod to slip and fret during tensile fatigue.

The effects of the radial displacements on the tensile stress distribution in the composite rod are shown in Fig. 9b and c. Fig. 9b shows the 3D distribution of stress within the gauge length, and near the grip edge (MAS = 50% UTS) in the plane where the greatest radial displacement occurred. The stress distribution along the gauge length is uniform within the CF core (1.7 GPa) and the GF shell (0.57 GPa). However, the discontinuity in stress arises at the core–shell interface because of the abrupt modulus mismatch between the two material systems (see Table 1). The longitudinal composite stress ( $\sigma_c$ ) can be evaluated as:

transition from longitudinal tension (caused by surface shear stresses) to longitudinal and transverse compression (caused by the radial load) occurs deeper within the grip. The plane in which the radial displacement is greatest causes the maximum longitudinal tensile stress (in both the GF shell and CF core) to increase to  $\sim 0.8$  GPa and  $\sim 1.83$  GPa, respectively. Fig. 9c shows that in the plane with the lowest radial displacement, the stress concentration region was smaller, indicating that lower radial displacements reduced stress concentrations.

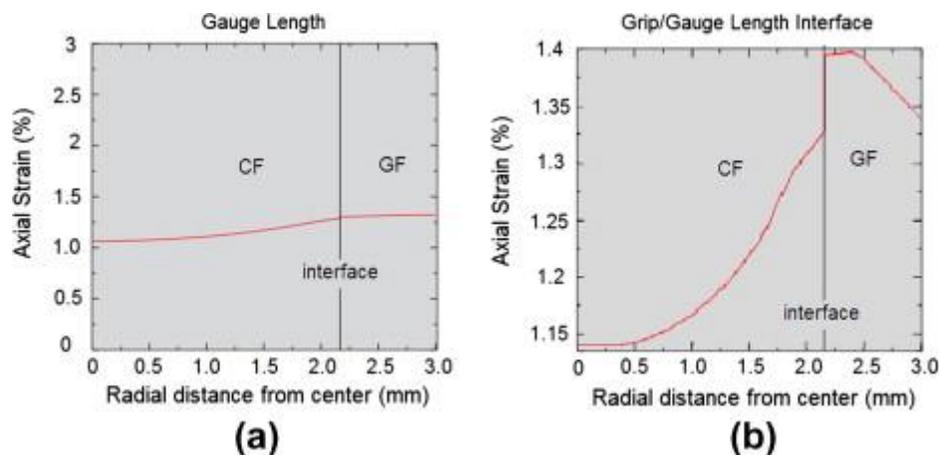
Fig. 10. (a) Axial strain at 50% UTS along gauge length and (b) non-uniform axial strain at interface.

Fig. 10a shows the longitudinal strain distribution within the gauge length at 50% UTS, where an isostrain condition exists at 1.1% strain. During tension fatigue, the composite was initially cycled between two positions where the two fiber types and the matrix reached uniform strains (within the gauge length). Fig. 10b shows that the axial strain increases along the GF/CF interface near the grip entrance, rising to a maximum of 1.4% in the GF shell. This distribution constitutes a strain gradient within the matrix near the GF/CF interface. During tension–tension fatigue, the strain gradient along the interface produced a shearing effect in the matrix and caused separation of the GF shell from the CF core, resulting in relative sliding between the CF core and the GF shell. These observations are consistent with previous observations of fatigue cracks initiating in regions of high matrix strain and propagating along stress concentration sites [18].

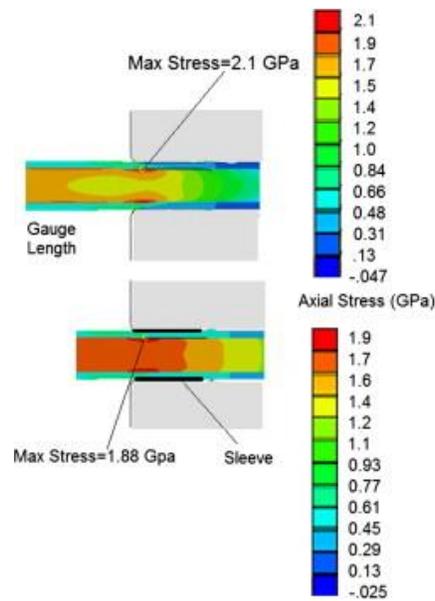
Fig. 11. Tensile stress distribution with and without sleeve.

To mitigate the issues of high interfacial stress concentrations and fretting fatigue within the grip, a new design consideration was proposed. The addition of a thin sleeve, (25 mm in length) near the grip/gauge length interface is contemplated to reduce the friction coefficient and the maximum radial displacement (within the region). The radial displacement was reduced from 0.18 mm to 0.10 mm and the friction coefficient was reduced by 20% in the 25 mm length region to hypothetically model the effect of a sleeve. The effect of such a sleeve on the stress distribution in the rod was analyzed using a 2D FE model, and the results are shown in Fig. 11. The simulation shows that stress concentrations were reduced by ~10% in both the GF and CF systems. The corresponding stress states in the 2D model are similar to those determined by the 3D model. If similar sleeves were implemented in service, they would reduce stress concentrations in the grip while allowing a lower more uniform distribution of radial displacement. This sleeve would also protect the GF shell from fretting fatigue damage caused by the sharp grooves in the grip design.
